## 6700 Lesson Learned

The purpose of this document is to outline issues discovered during field visits by HME representatives and how to fix them. Issues reported were generally related to poor audio quality. This guide outlines causes, solutions and best practice wiring standards.

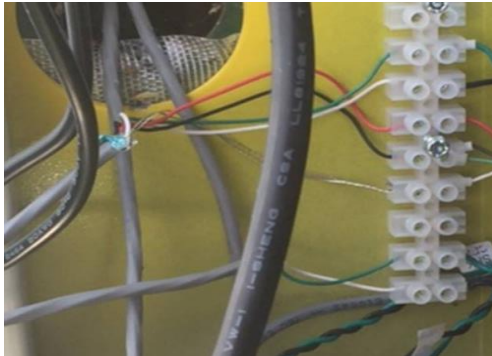
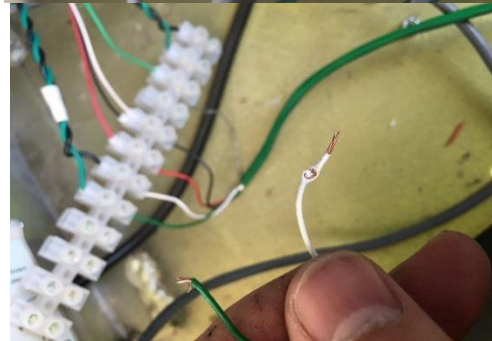
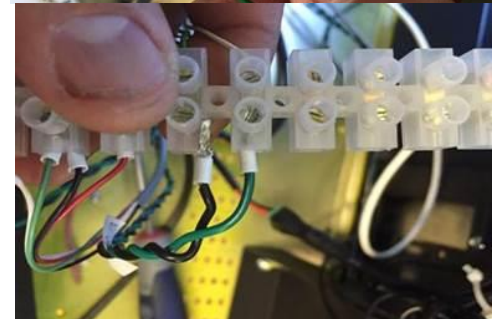
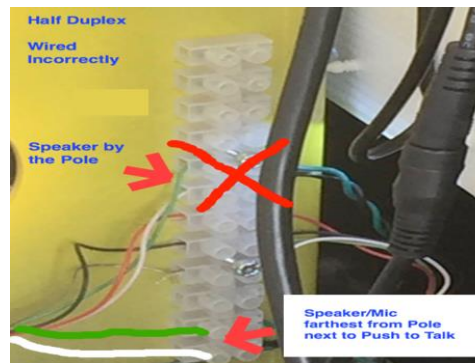
### Incorrect Wiring

Bad connections at the terminal block at the stalls results in weak signal flow and low/poor audio.

Terminal blocks in the stalls are slightly too big for 22 AWG wiring. Most of the time a few strands are not grabbed by the screw. If the wiring is not stripped back far enough the screw pinches down on insulation instead of stranded wires. In either case, audio quality will suffer.

1. Strip back insulation to reveal the 2 twisted pairs, making sure it's not too long.
2. Strip the wire insulation twice as long as you normally would, e.g., 12mm instead of 6mm.
3. Twist the strands tightly together, then fold the strands back in half, which doubles the strands and helps guarantee the wire will be securely retained.
4. Insert wire, tighten terminal block screw, and verify with a gentle tug. It's better to pull and have it fail now than later!
5. Make sure to wire the microphone as the audio element on the left part of the POP, not the right.

6. Cover the shield wire with insulation
7. Check the POP/Fabcon wiring on the other side of the terminal block if any issues persist.
