## 6700 Lesson Learned

The purpose of this document is to outline issues discovered during field visits by HME representatives and how to fix them. Issues reported were generally related to poor audio quality. This guide outlines causes, solutions and best practice wiring standards.

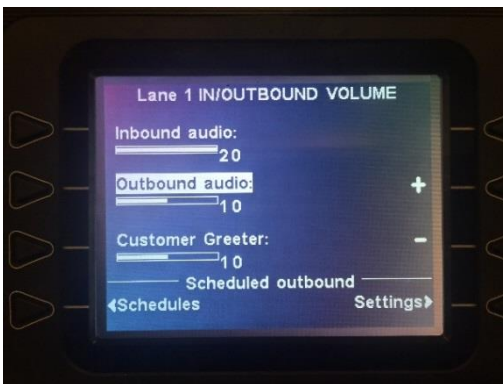
Poor audio quality is often caused by incorrectly adjusted audio levels. Turning the inbound and outbound levels to maximum settings is likely to result in distortion or echoing.

**Ensure any audio adjustments are uniformly adjusted on all base stations and saved under Installer Settings.**

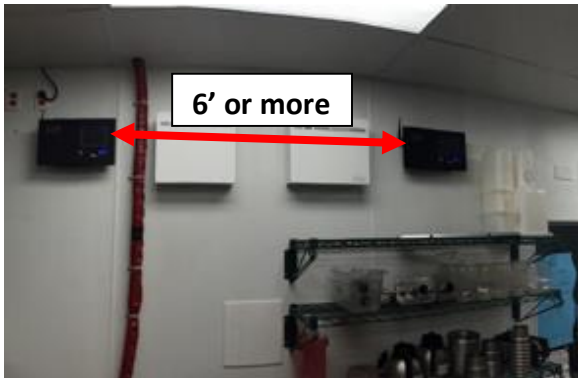
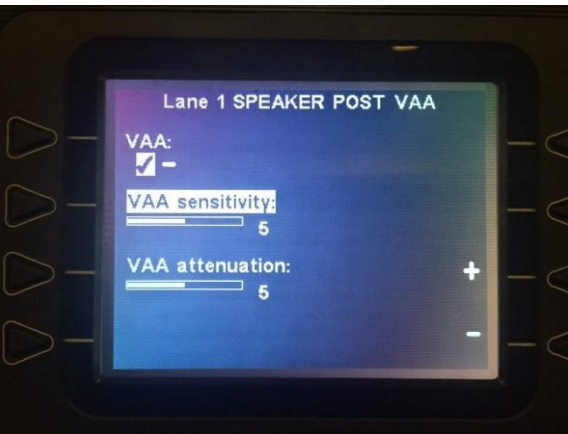
### Echoing

You may notice a slight echoing (your own voice being heard back in your headset) when taking an order. A small amount of echo that lasts a few seconds after you connect to a stall is normal. Severe echo, or persistent through an entire order is not.

Adjusting VAA settings is a delicate balance. The idea is to set your sensitivity so it activates when the person wearing the headset is speaking. You do not want VAA activating when people are talking near the order taker or when other ambient noise is present. This will cause the customer's voice (inbound audio) to drop in volume.

When adjusting attenuation, the goal is for VAA to eliminate echo, but not to cancel out all inbound audio.

1. **DO NOT** set both sensitivity and attenuation to maximum. This may work well during the early morning or late at night when it's quiet inside the building; when ambient noise increases around the order takers, inbound volume will drop below an acceptable level.
2. *Tip* – Set Sensitivity to 5 and attenuation to 6 as a starting point. Try this and make changes from there.
